FIRE ISOLATOR

FIRE RESEARCH ON EV- CAR FIRES

SAFETY ONBOARD FERRIES AND IN CARPARKS

FIRE SAFETY TESTING IN FREDRIKSHAVN

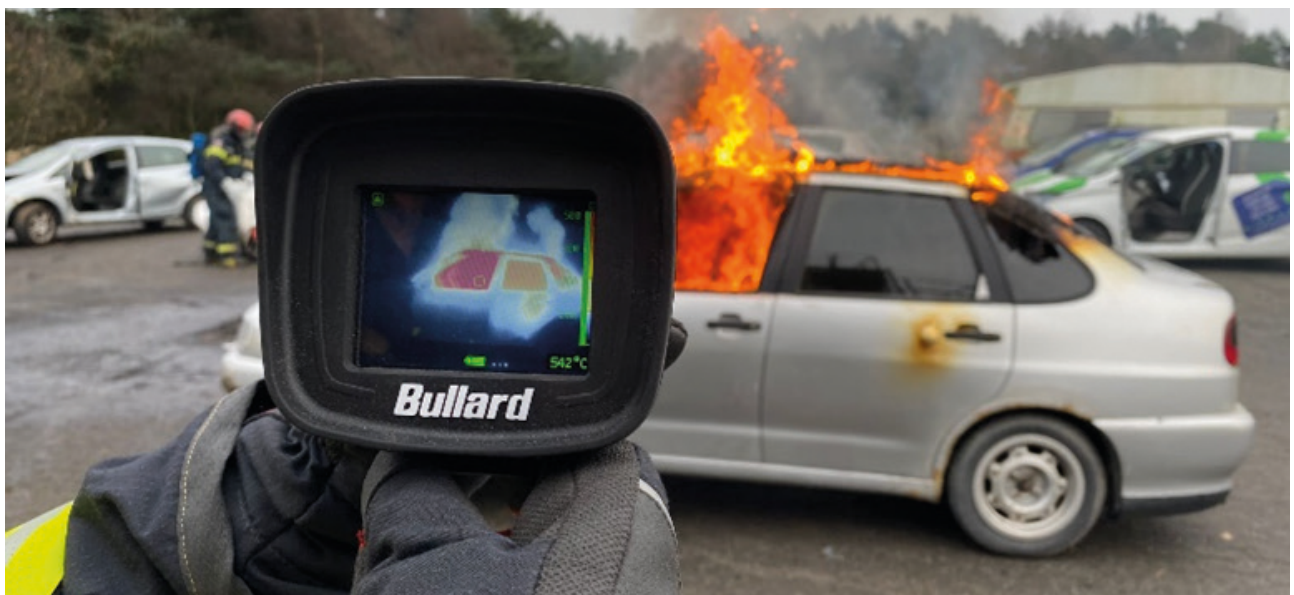
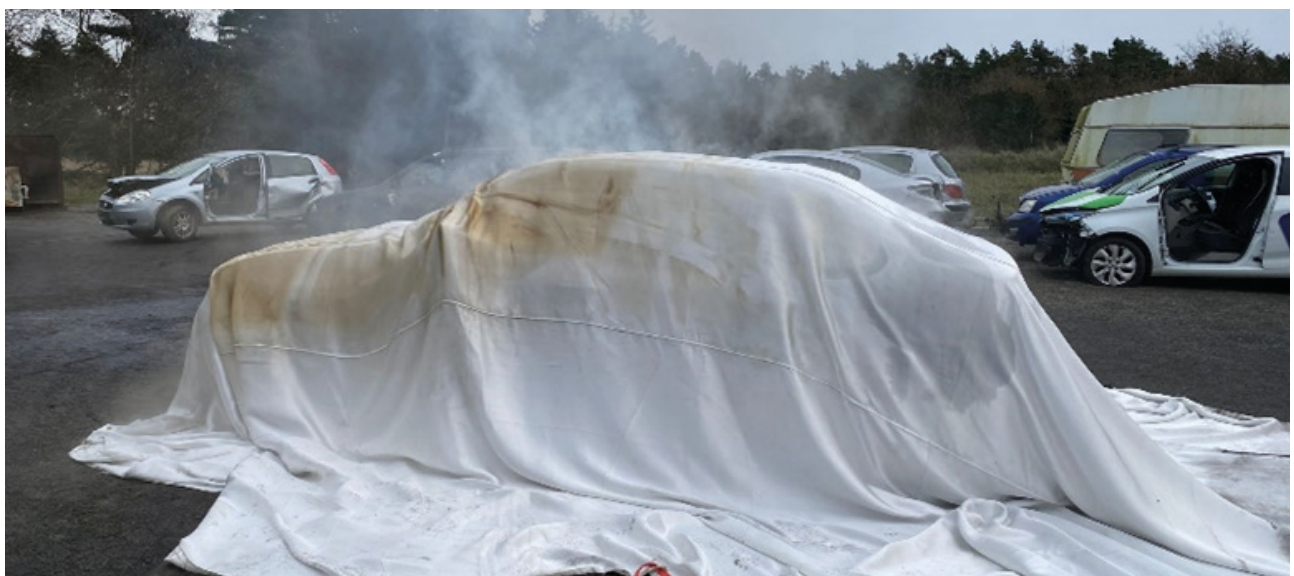
A long term test was done on a normal combustion vehicle, our Seat.

Here the temperature was around 500-600 °C.

Blanket could stand temperature without any defects except discoloring due smoke

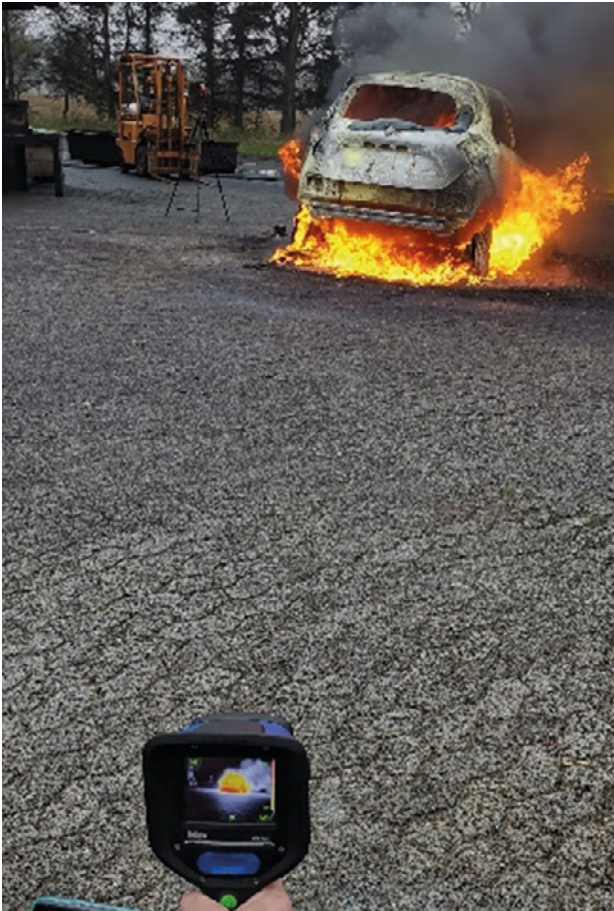
The same blanket was reused on an EV vehicle with a burning battery, where the temperature rose to 1325°C for just a short period of time when the thermal runaway of the batteries occurred again the blanket easily withstood the temperature and kept the fire contained.

The blanket was reused from a normal car to an EV car. What is most important is to use a light colored blanket to detect damage, cracks or tears in the blanket.

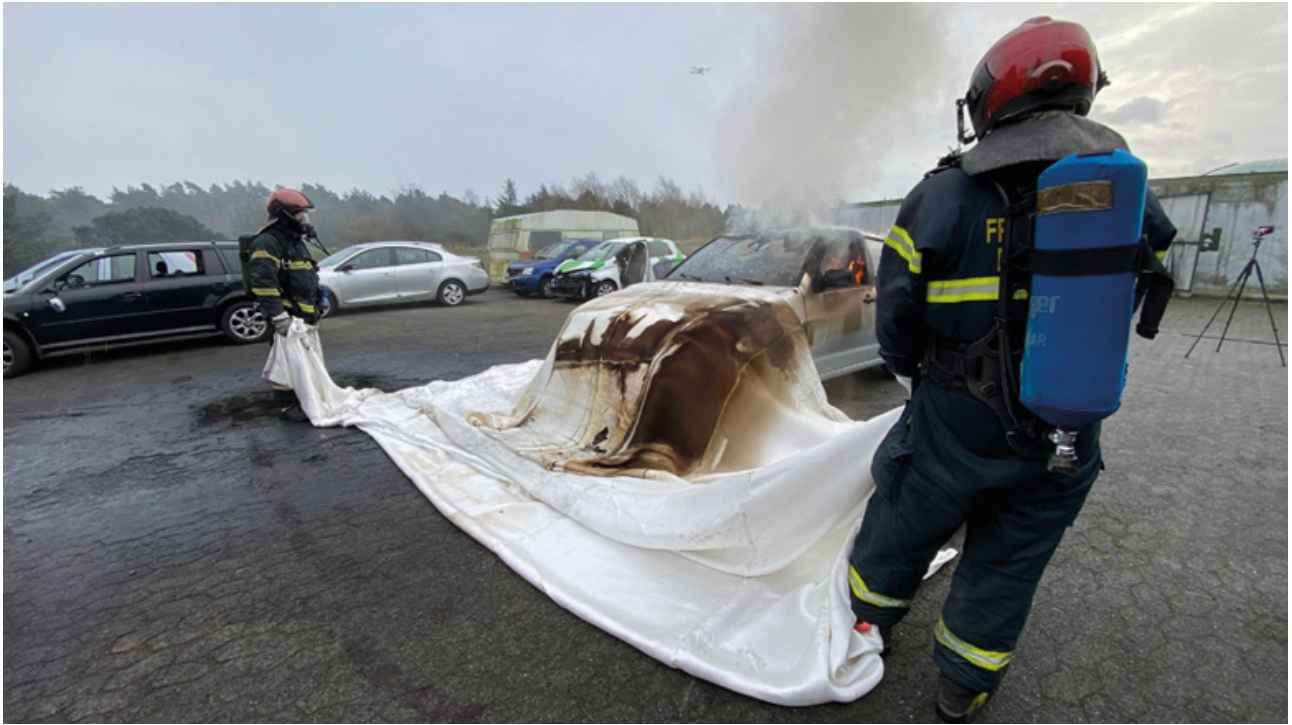
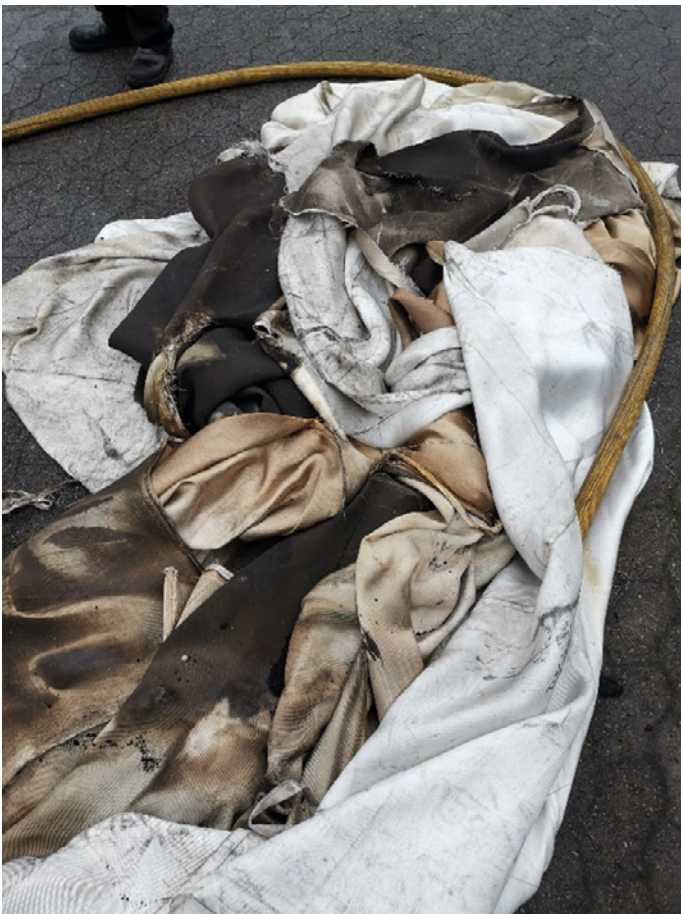
However, after hours of use in a fire involving Lithium batteries, the blanket is badly discolored and so dirty and smells so terrible that it will be generally disposed of according to the firefighters' statement.

Also due to the fact that the blanket is poisoned with HF gases and other toxic fumes.

These photos show the blankets after hours of use on a burning vehicle.

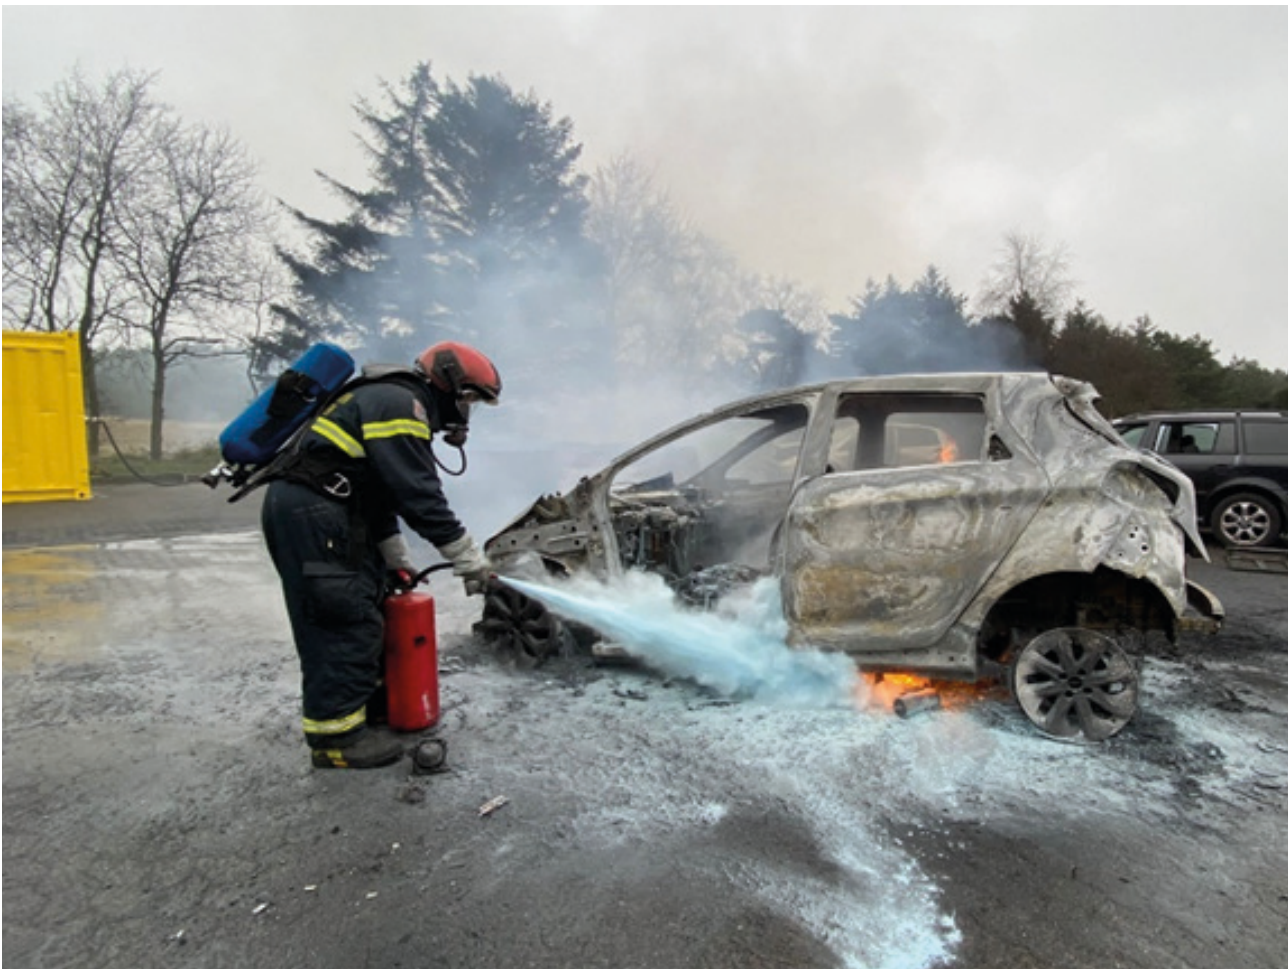
Since there are so-called lithium extinguishers on the market we made several attempts to extinguish a burning battery of a Renault Zoe.

Result even after 6/10 attempts the battery started to burn again each time so we cannot call this a success.

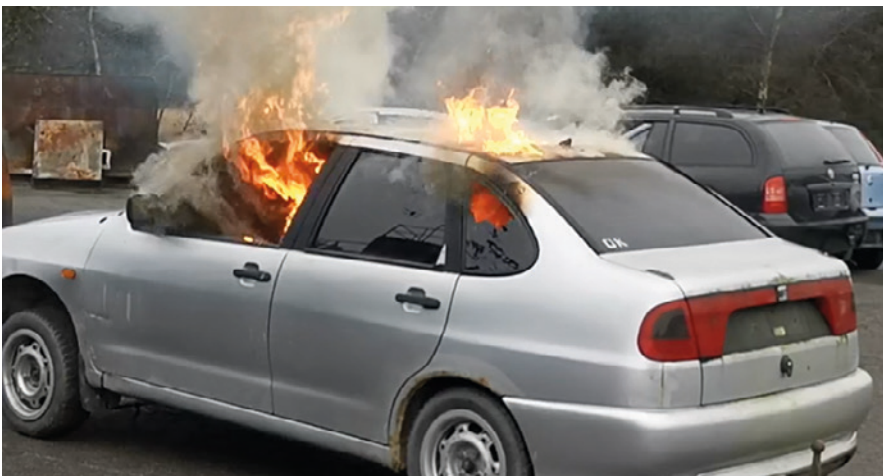
Fire before

We tested the potassium salt aerosol units, see photo 1, in a burning car (our Seat) and once the gas spread in the car the fire was extinguished in seconds, which however caused a huge amount of smoke.

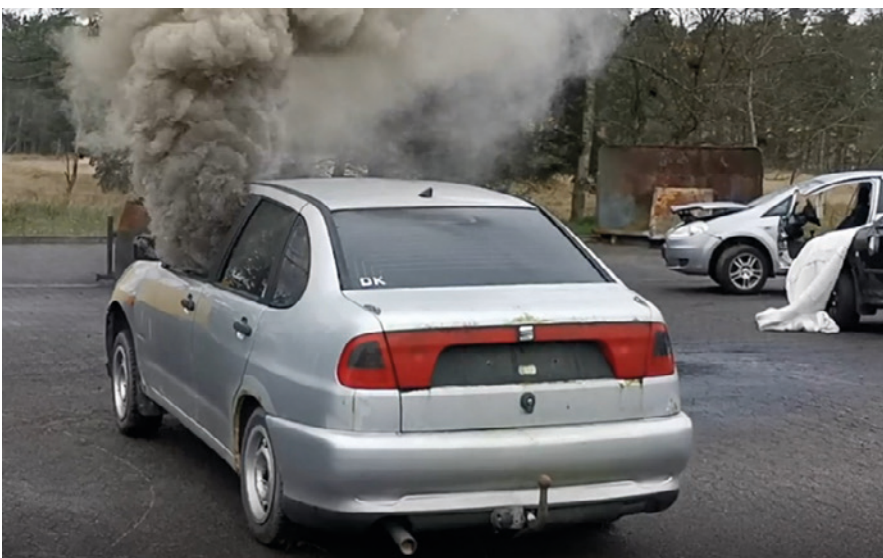
However after a while when the potassium gas had evaporated from the car the fire started again. When used in combination with a blanket, the fire stays out for a long time.

The fire 10 seconds after inserting the potassium salt aerosol units inside the burning car

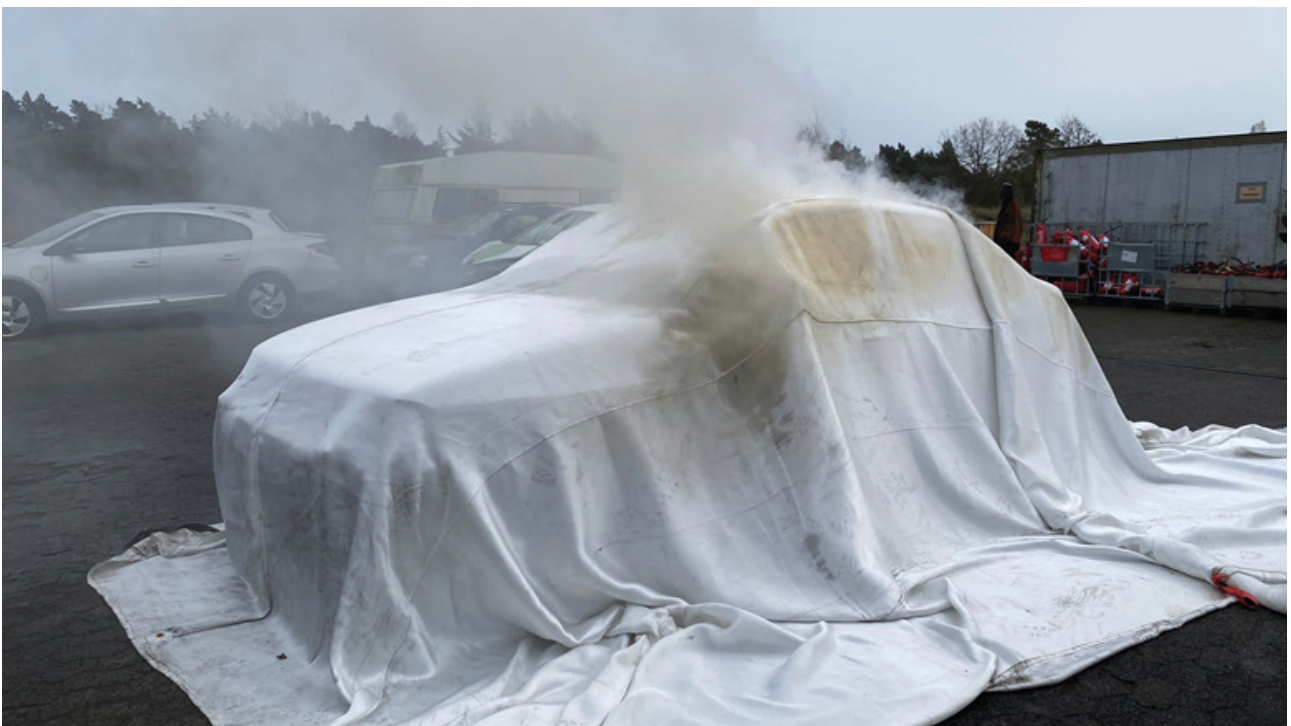
When covering a vehicle with the VR0906Li blanket, the fire was isolated, and when a potassium salt aerosol unit was inserted into and under the vehicle, the fire was under control for several hours.

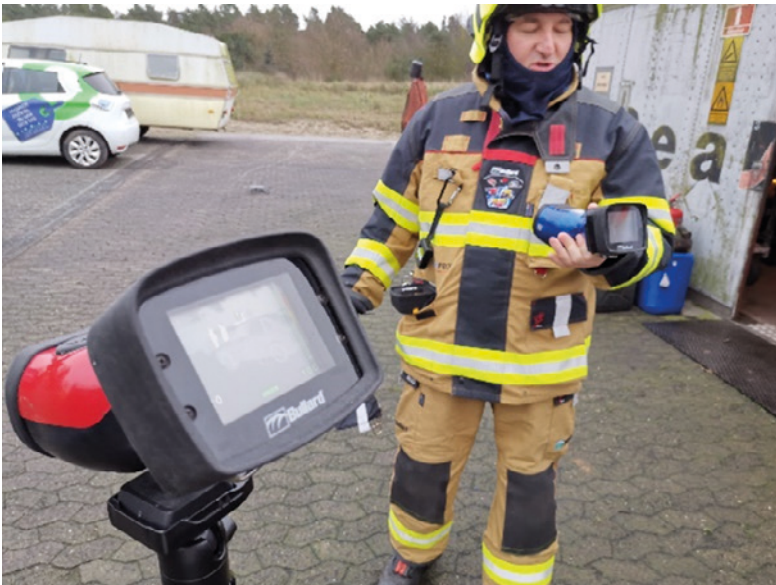
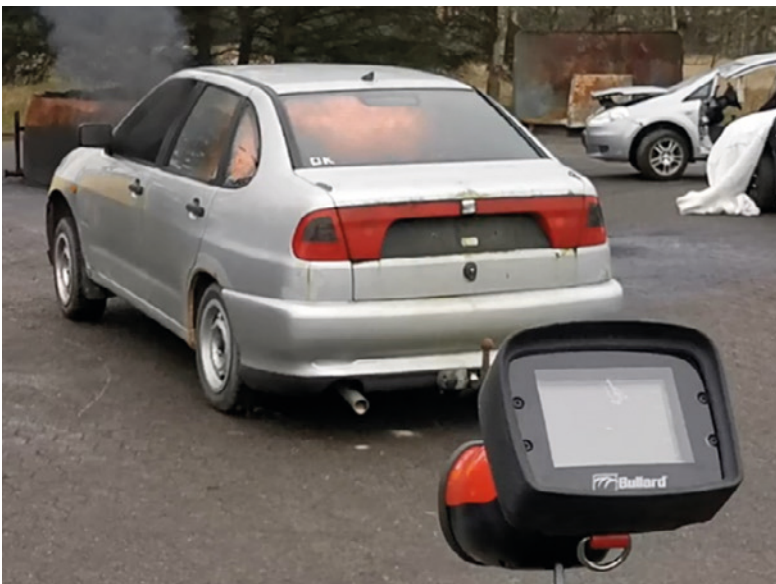
Specialist Rodic from Bullard visualized and compared the temperature range of a fire in a combustion car (gasoline, diesel) and an EV car.

- 1 Temperature range Combustion cars up to 600-700 °C.
- 2 Temperature range EV cars (our specimen) 700-800 °C with short bursts up to 1325 °C.

It is expected that when other EV cars burn with a larger battery pack the short temperature bursts will be more intense and for a longer period of time.

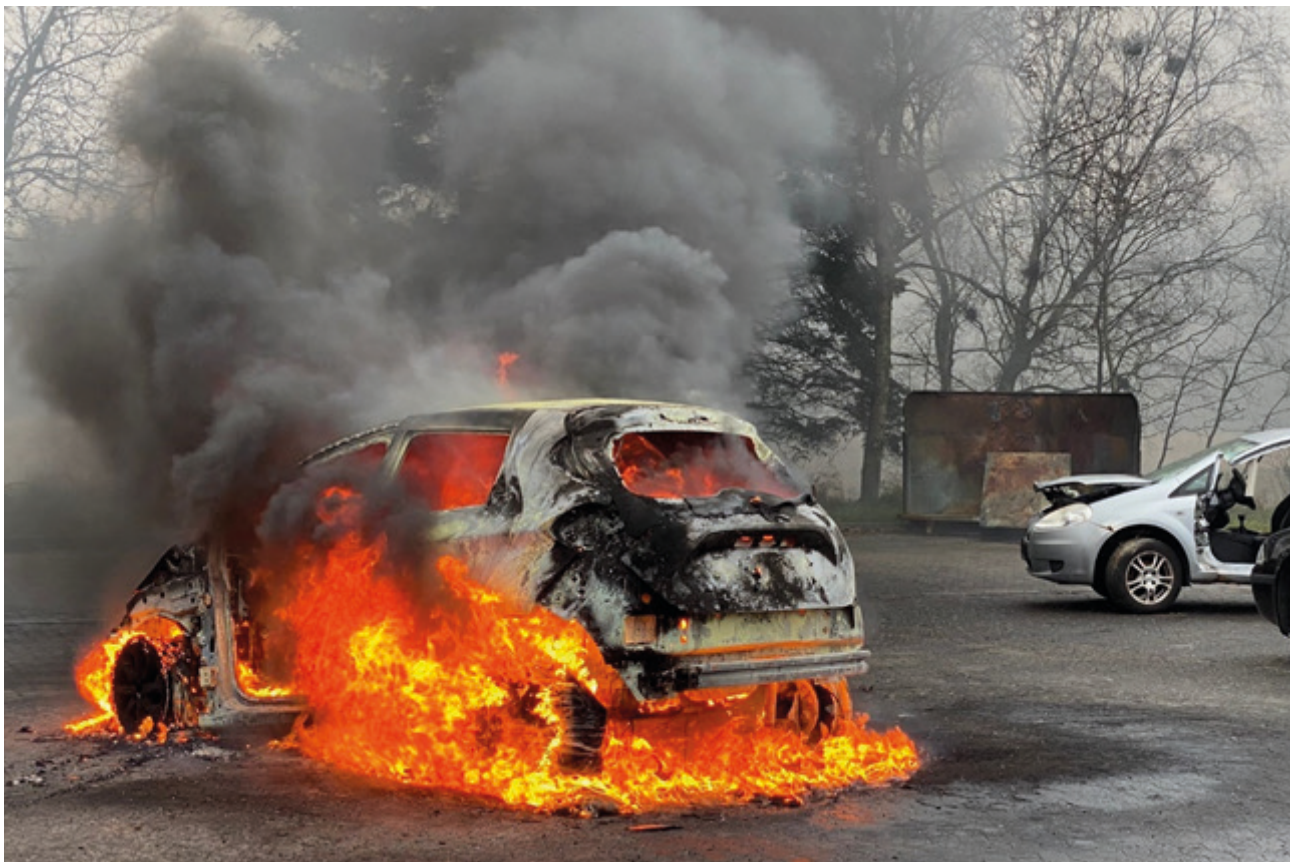
After 10 attempts to successfully extinguish the fire we stopped due to the fact that after every 5 seconds after the fire hose stopped the fire automatically reignited.

The photo below is from 20 seconds after the successful extinguishment, this went on and on and on.

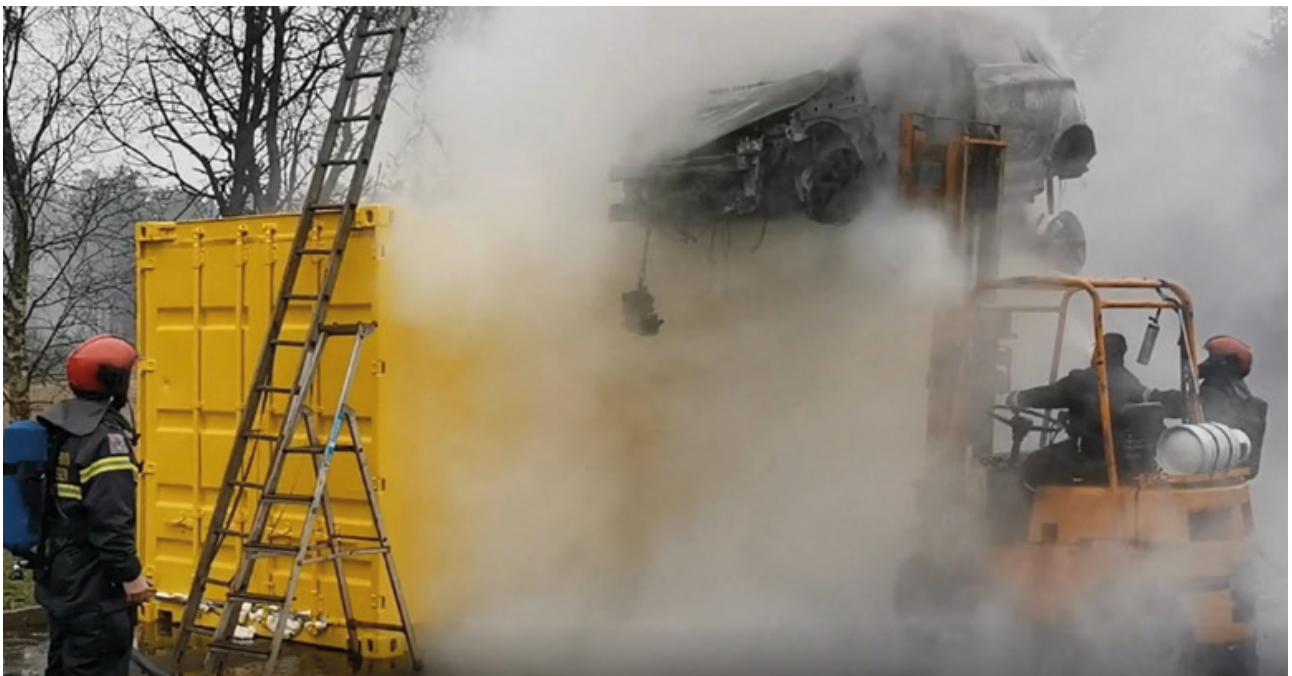
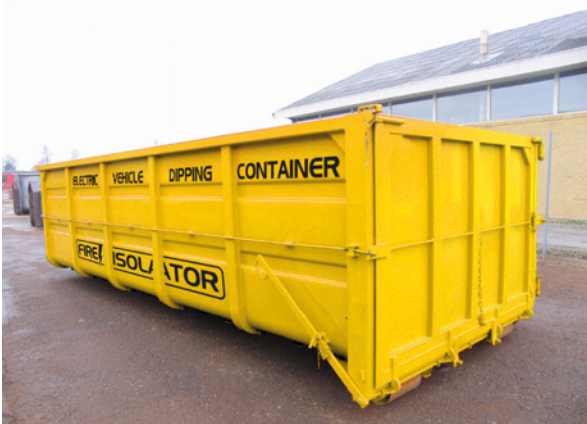
Our isolated EV car was still burning after several extinguishing attempts. As has been practiced in several countries, EV cars can also be dumped into water-filled containers.

This test also used a modified container with special inlet and outlet for water.

The ditched car is harmless, nothing more happened except that the temperature of the water raised from 8 °C to 15 °C within an hour.

It is recommended that the car be left in there for 2 weeks. After this, the water is chemical waste and must be treated as such and disposed of in a special way.

Ports should be equipped with ditch containers, these containers should be 75% filled with water when the ship arrives and the EV car should be dumped there and left for 2 weeks.
